1. AGENCY USE ONLY (Leave blank)	2. REPORT DATE 1996	3. REPORT TYPE AND DATES COVERED Final Report		
4. TITLE AND SUBTITLE The Old Hospital Complex (5EP1778) Fort Carson, Colorado		5. FUNDING NUMBERS

13. ABSTRACT (Maximum 200 words) <p>The Old Hospital Complex (5EP1778) at Fort Carson, Colorado, consists of 59 buildings. The Complex was built during World War II and is significant due to its association with the history of the United States. The complex is semi-permanent construction, constructed from the Department of the Army's Series 800 plans. This report documents the complex in accordance with Section 1(g) of the Memorandum of Agreement enacted among the Department of the Army, Headquarters Fort Carson, the Colorado State Historic Preservation Office, and the Advisory Council on Historic Preservation.</p> <p style="text-align: center;">DTIC QUALITY INSPECTED 2</p>

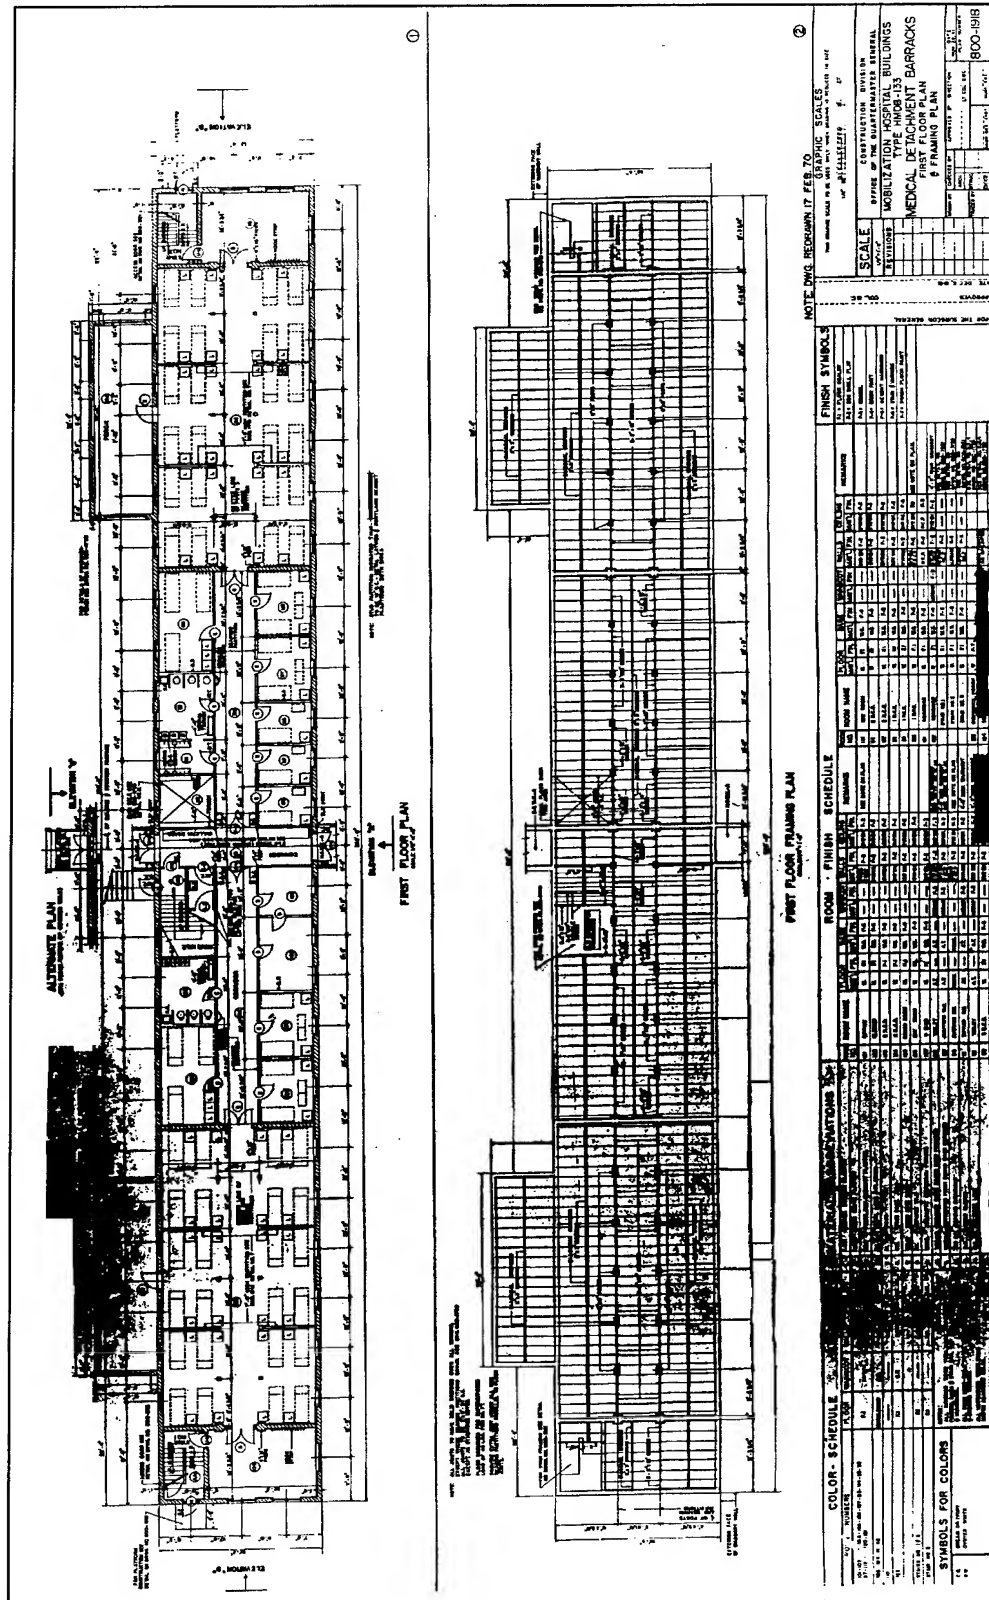
Figure V.145 5EP1778. First-floor plan for Building S6281, Medical Detachment Barracks, BUD Series.

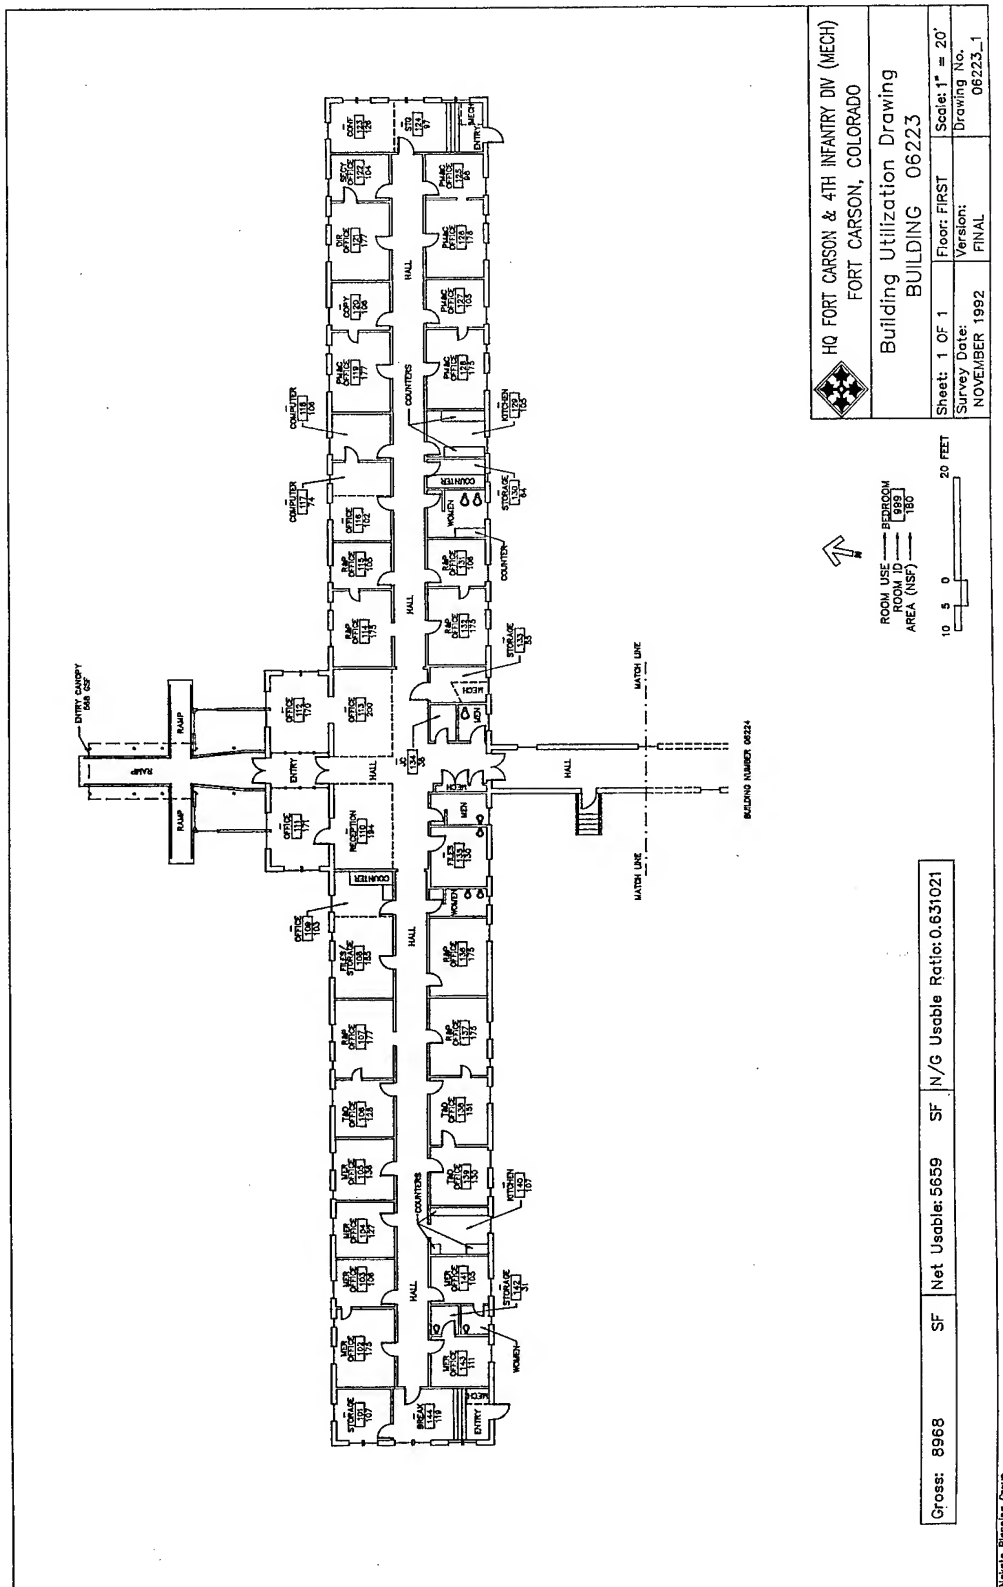
Figure V.152 5EPI778. First-floor plan for Building S6223, Nurses or Officers Quarters, BUD Series.

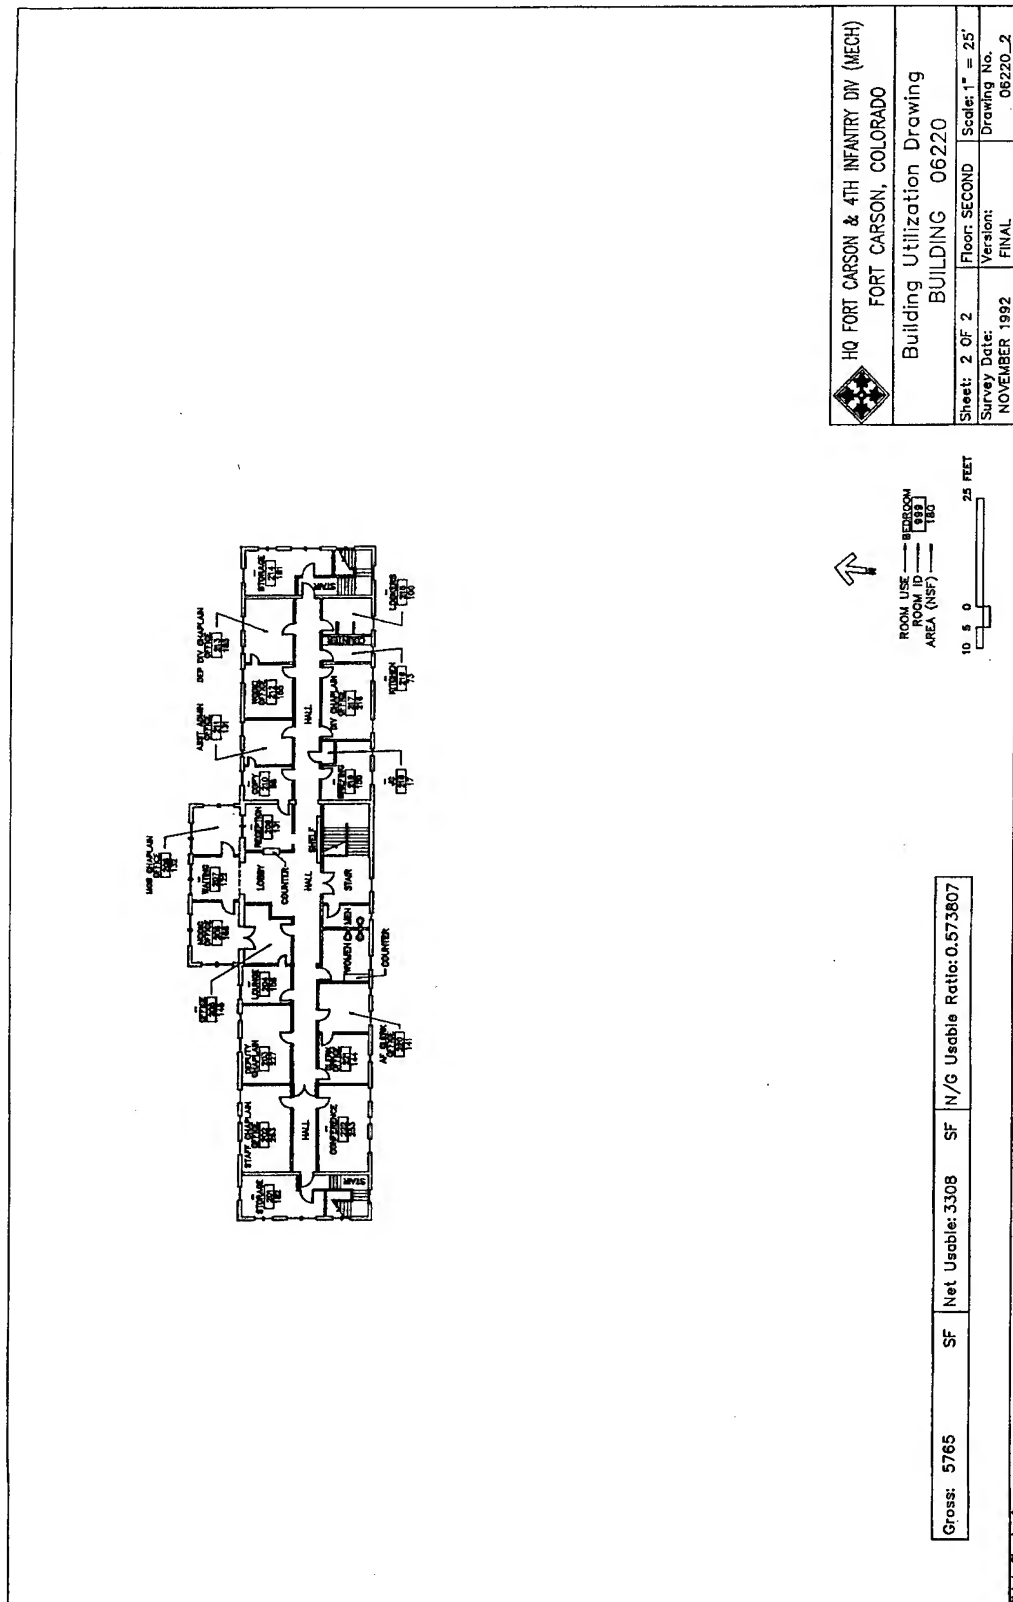
Figure V.164 5EP1778. Second-floor plan for Building S6220, Hospital Nurses Quarters, CSA-362, BUD Series.

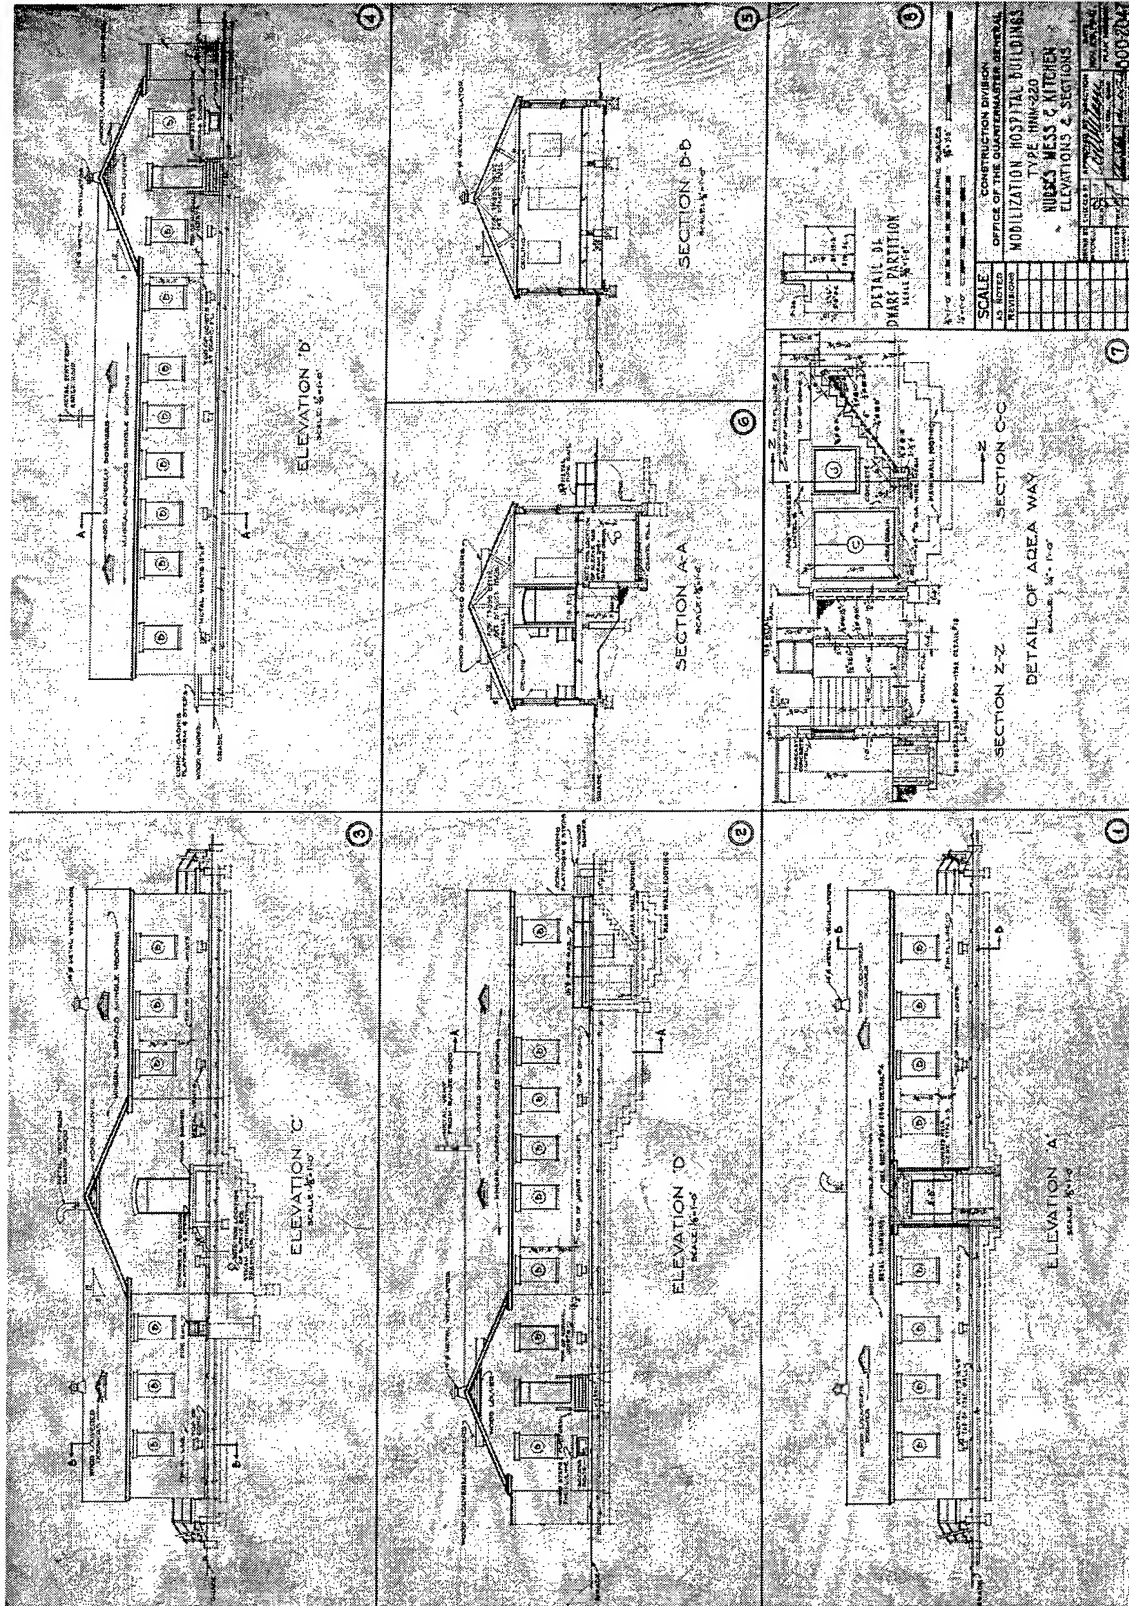
Figure V.182 5EP1778. Elevations and sections for Building S6221, Nurses Mess and Kitchen, 800 Series, Type HNM-220, Plan 800-2047.

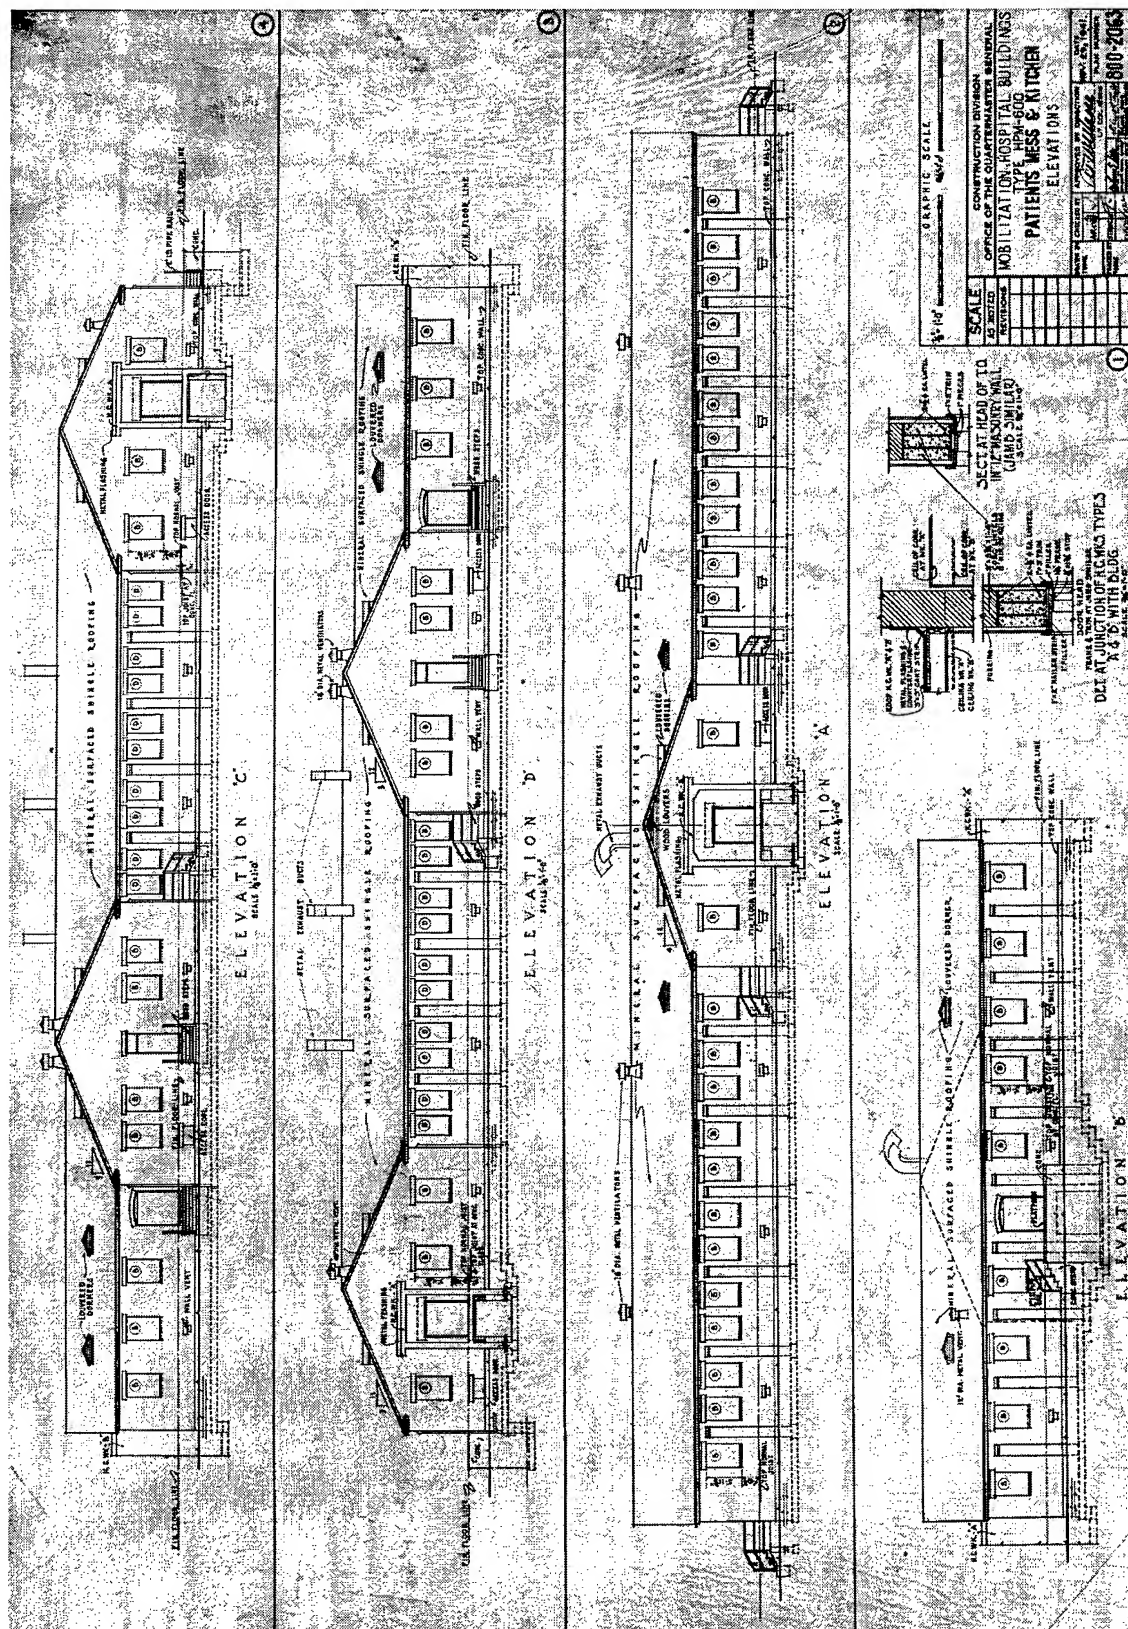
Figure V.188 SEP1778. Elevations for Building S6250, Patients Mess and Kitchen, 800 Series, Type HPM-600, Plan 800-2063.

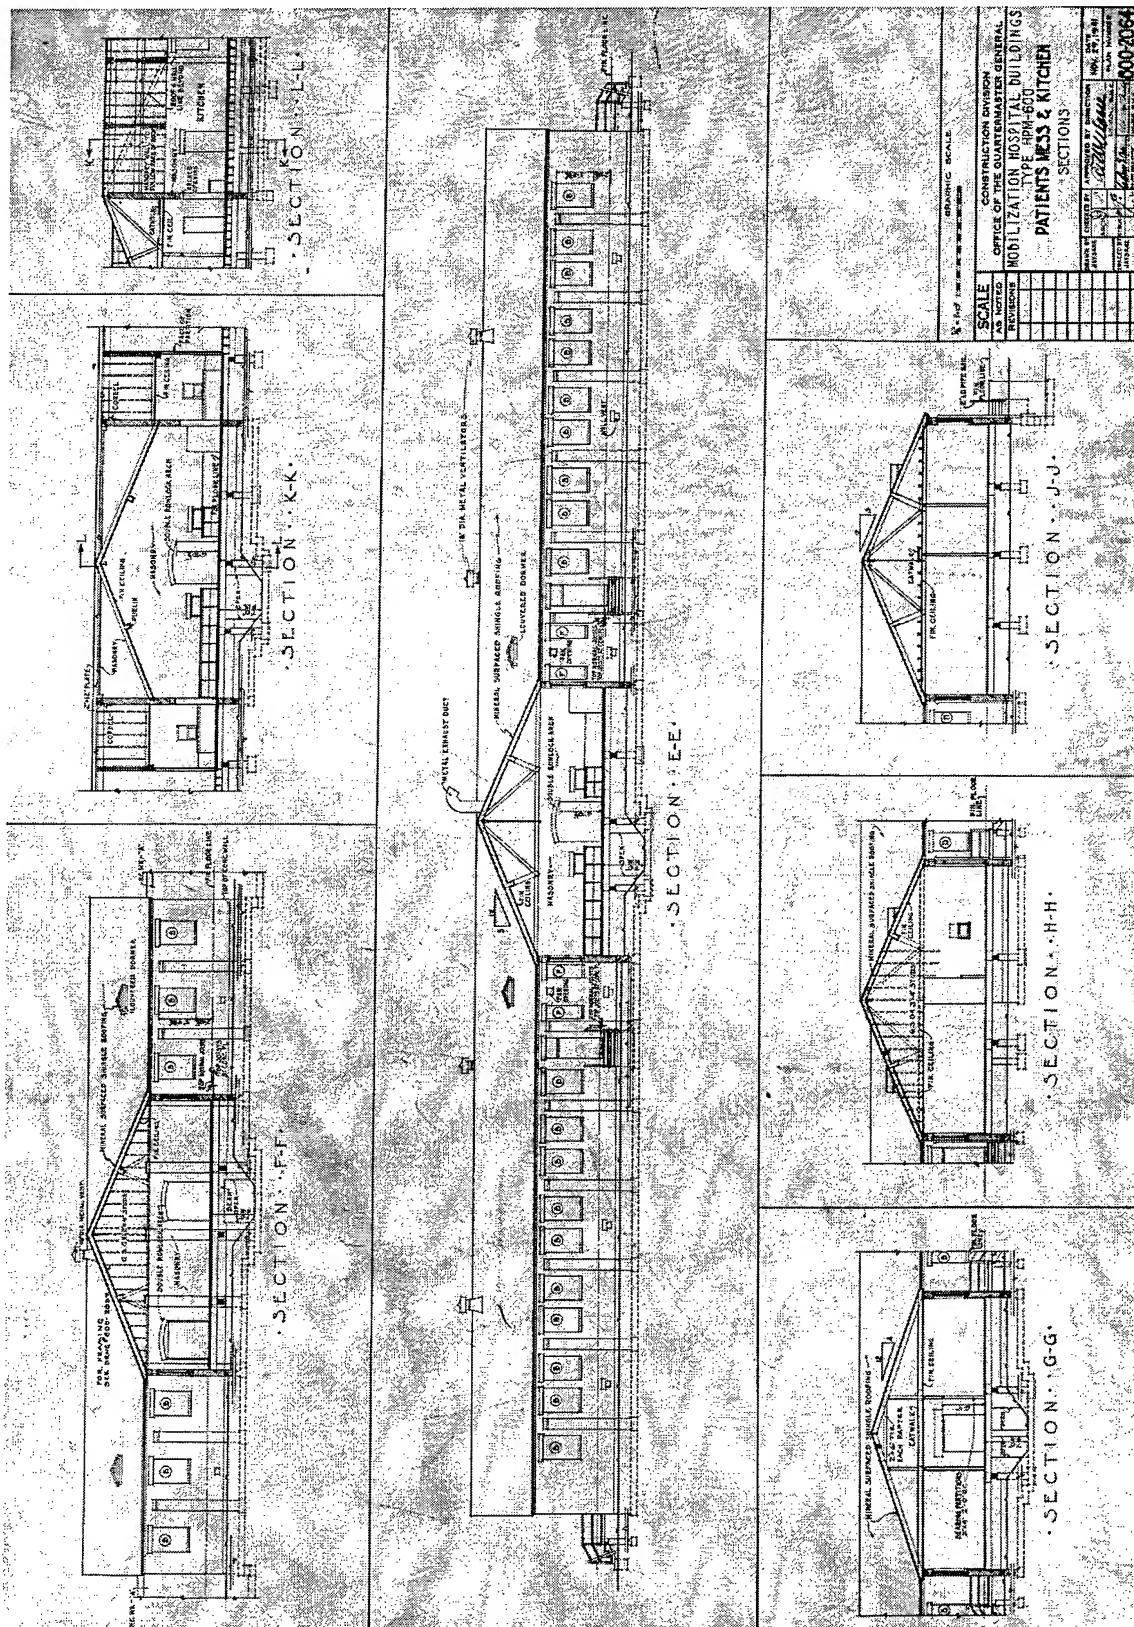
Figure V.189 5EPI778. Section plans for Building S6250, Patients Mess and Kitchen, 800 Series, Type HPM-600, Plan 800-2064.

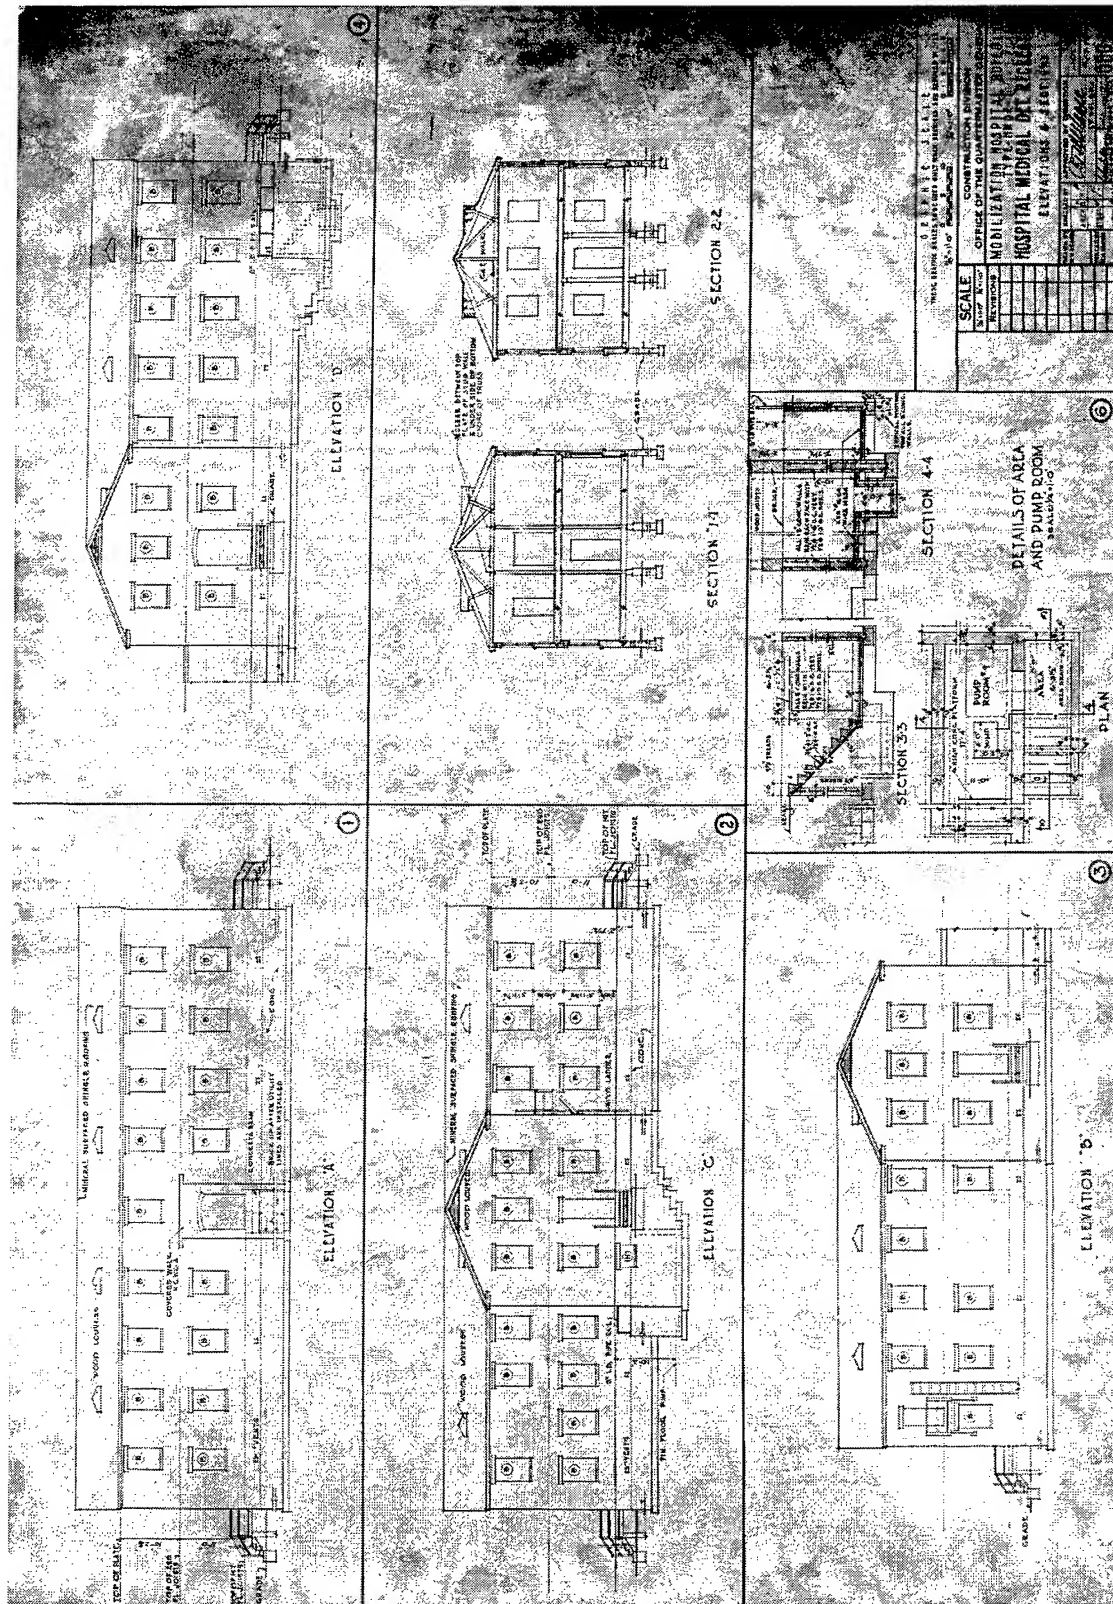
Figure V.198 5EPI778. Elevations and sections for Building S6287, Hospital Medical Detachment Recreation, 800 Series, Type HMDR-1, Plan 800-1812.

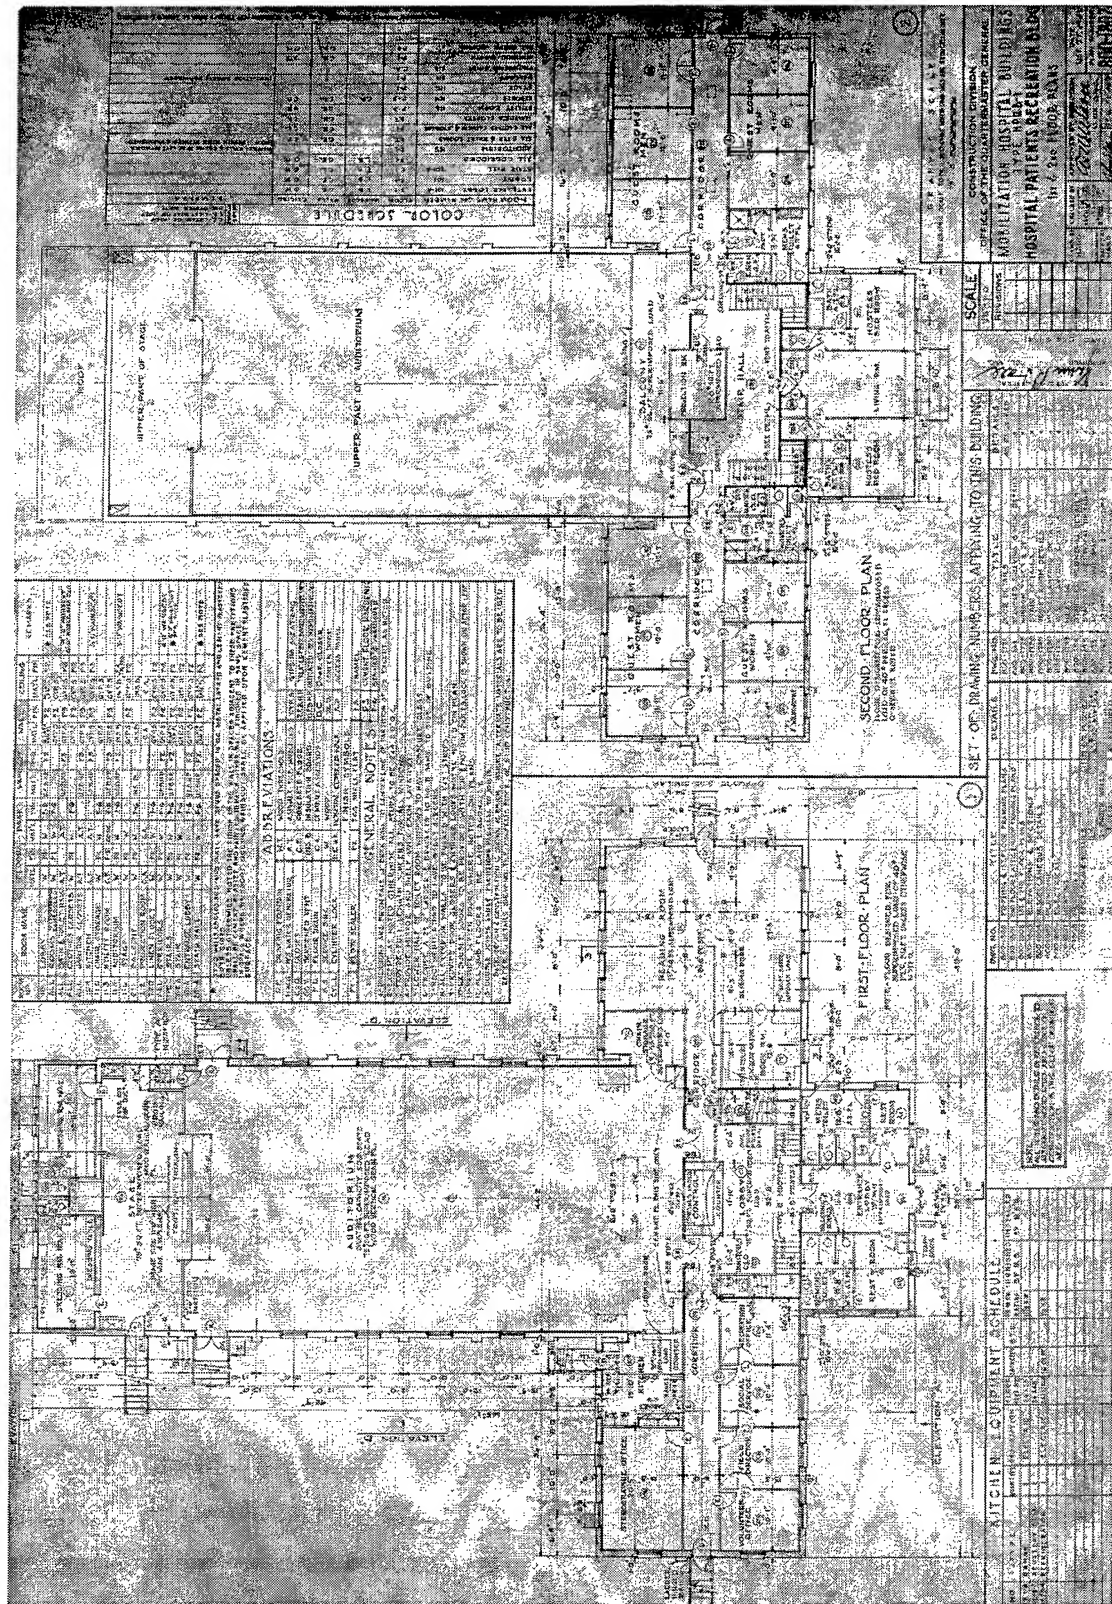
Figure V.203 5EPI778. First- and second-floor plans for Building S6251, Hospital Patients Recreation, 800 Series, Type HPRB-1, Plan 800-1802.

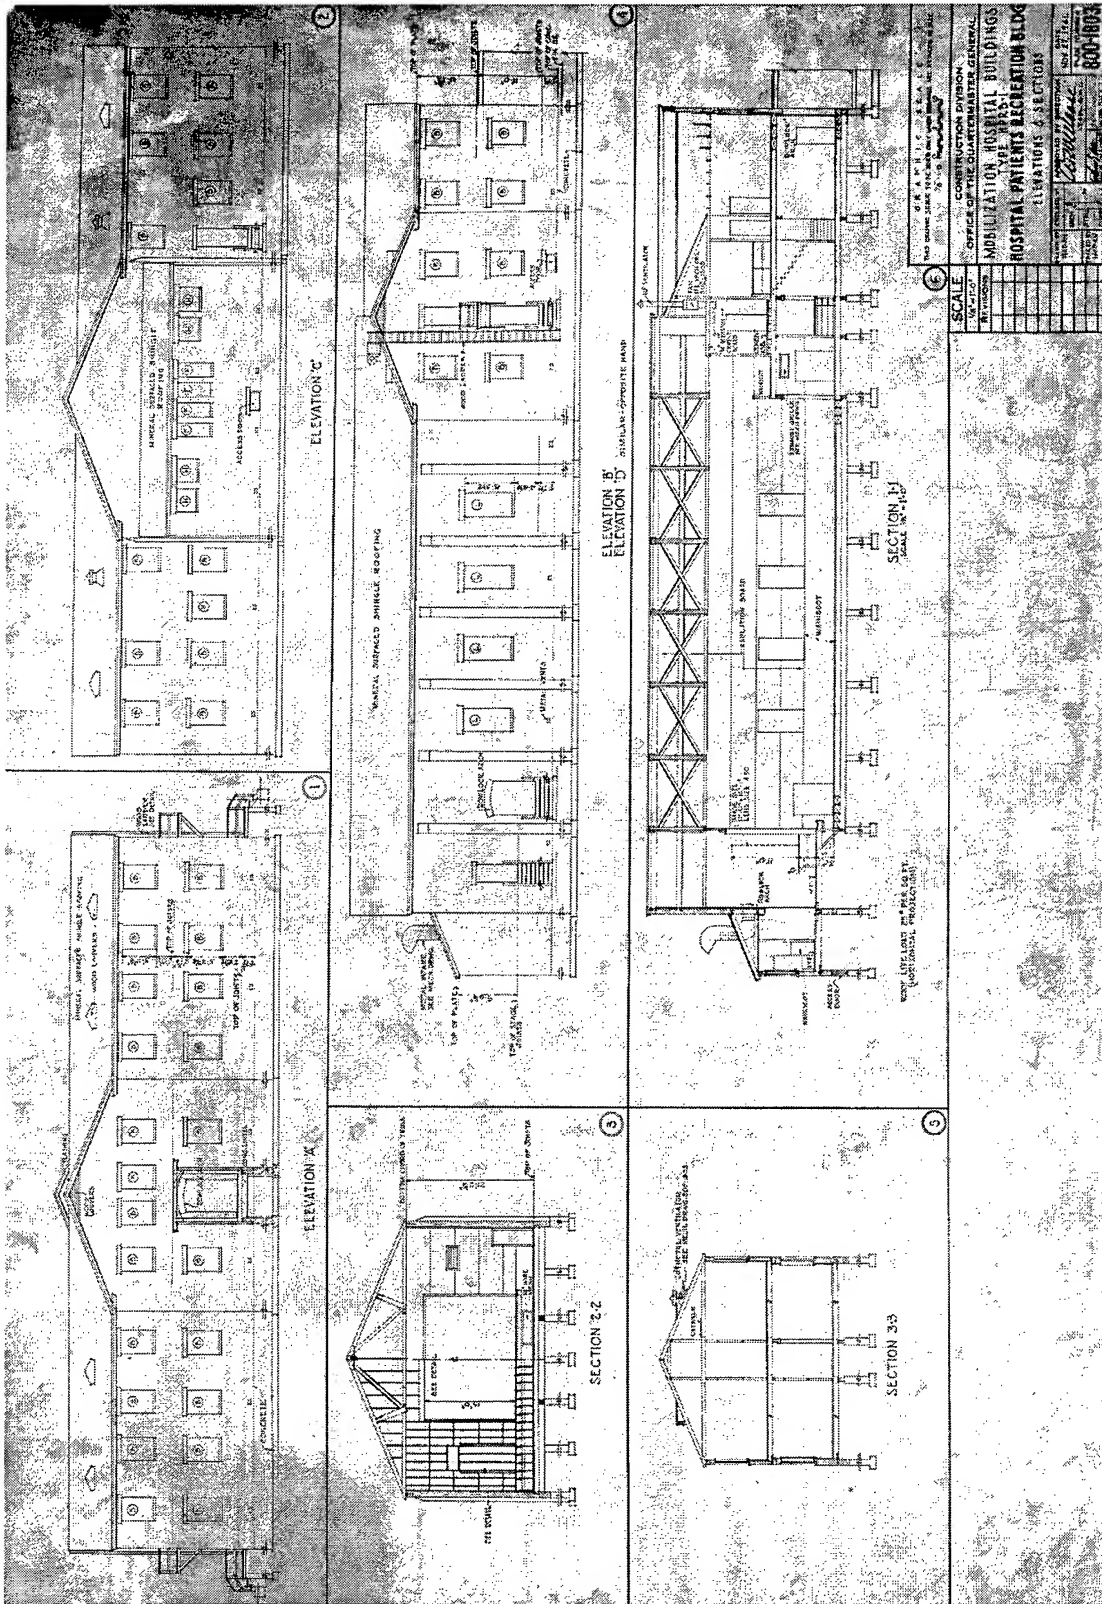
Figure V.204 5EPI778. Elevations and sections for Building S6251, Hospital Patients Recreation, 800 Series, Type HPRB-1, Plan 800-1803.

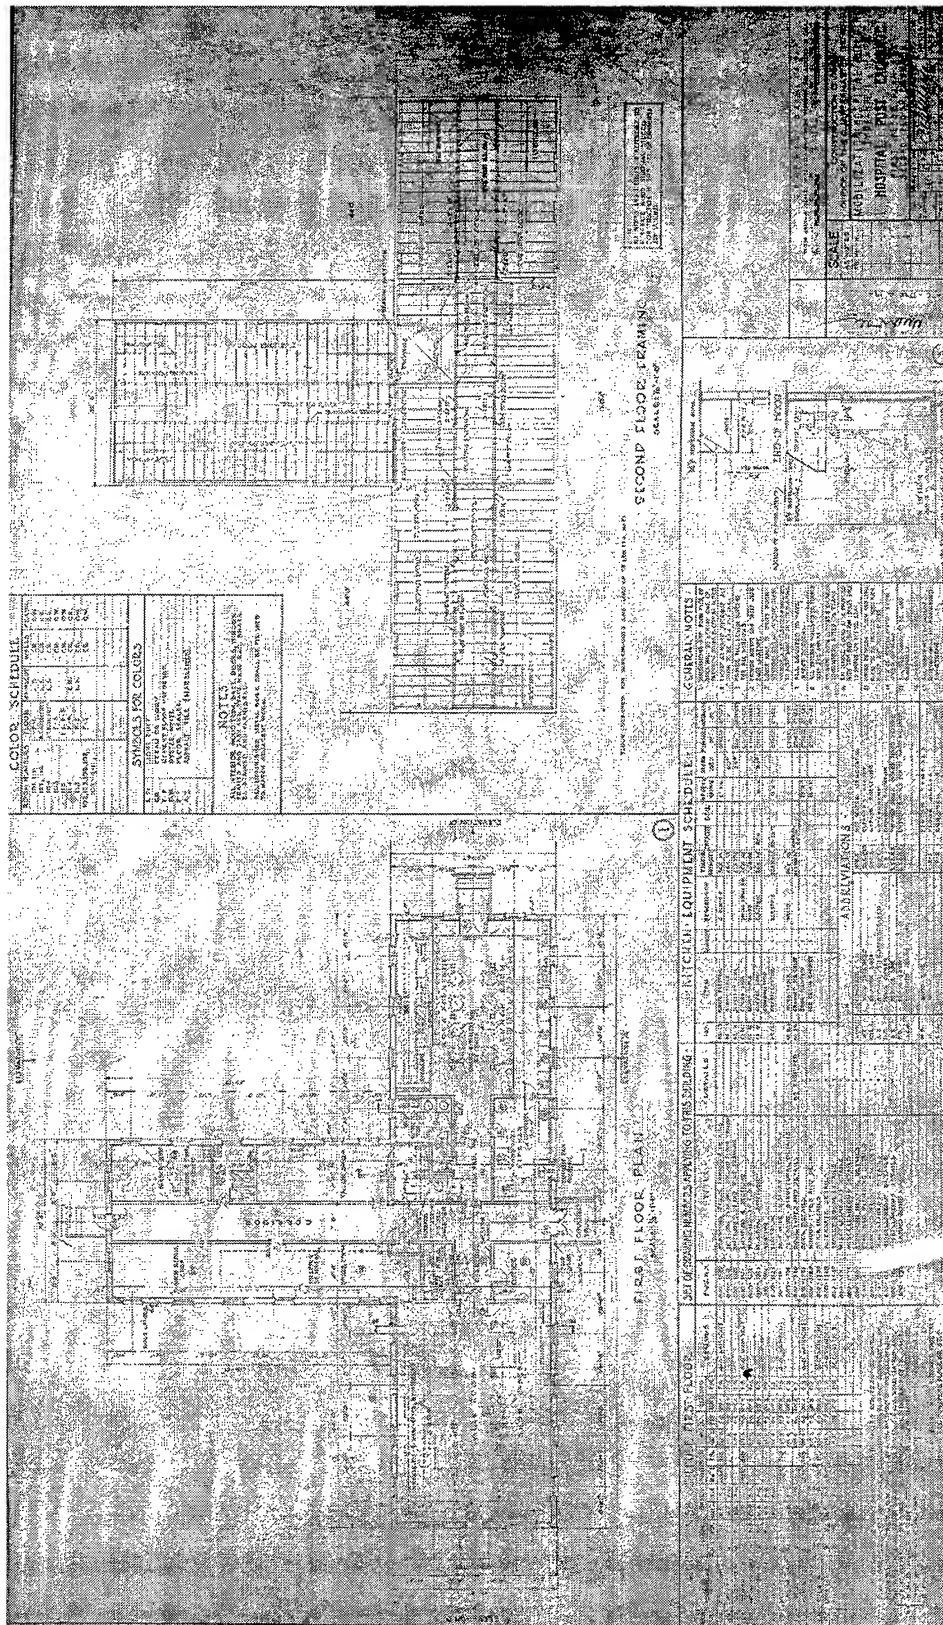
Figure V.218 5EP1778. First-floor plan and second-floor framing plan for Building S6261, Hospital Post Exchange, 800 Series, Type HPE-1, Plan 800-1819.

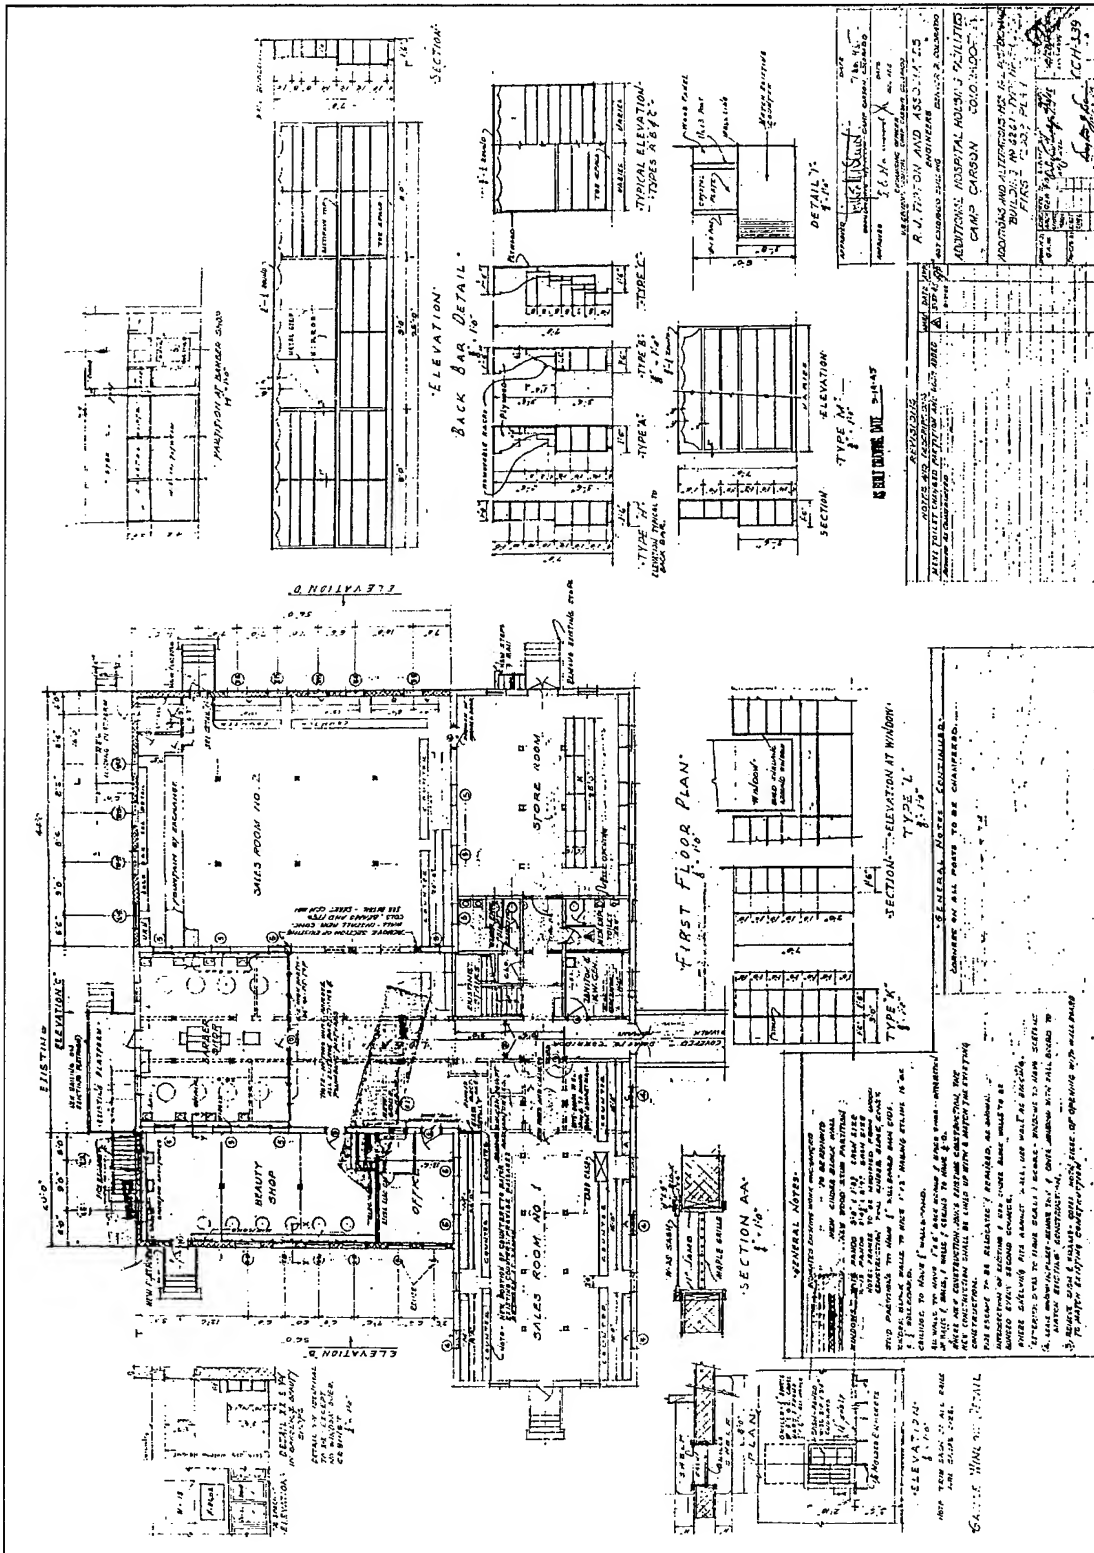
Figure V.222 SEP1778. Additions and alterations plans for the first floor of Building S6261, Hospital Post Exchange, CCH Series, Sheet 3.39.

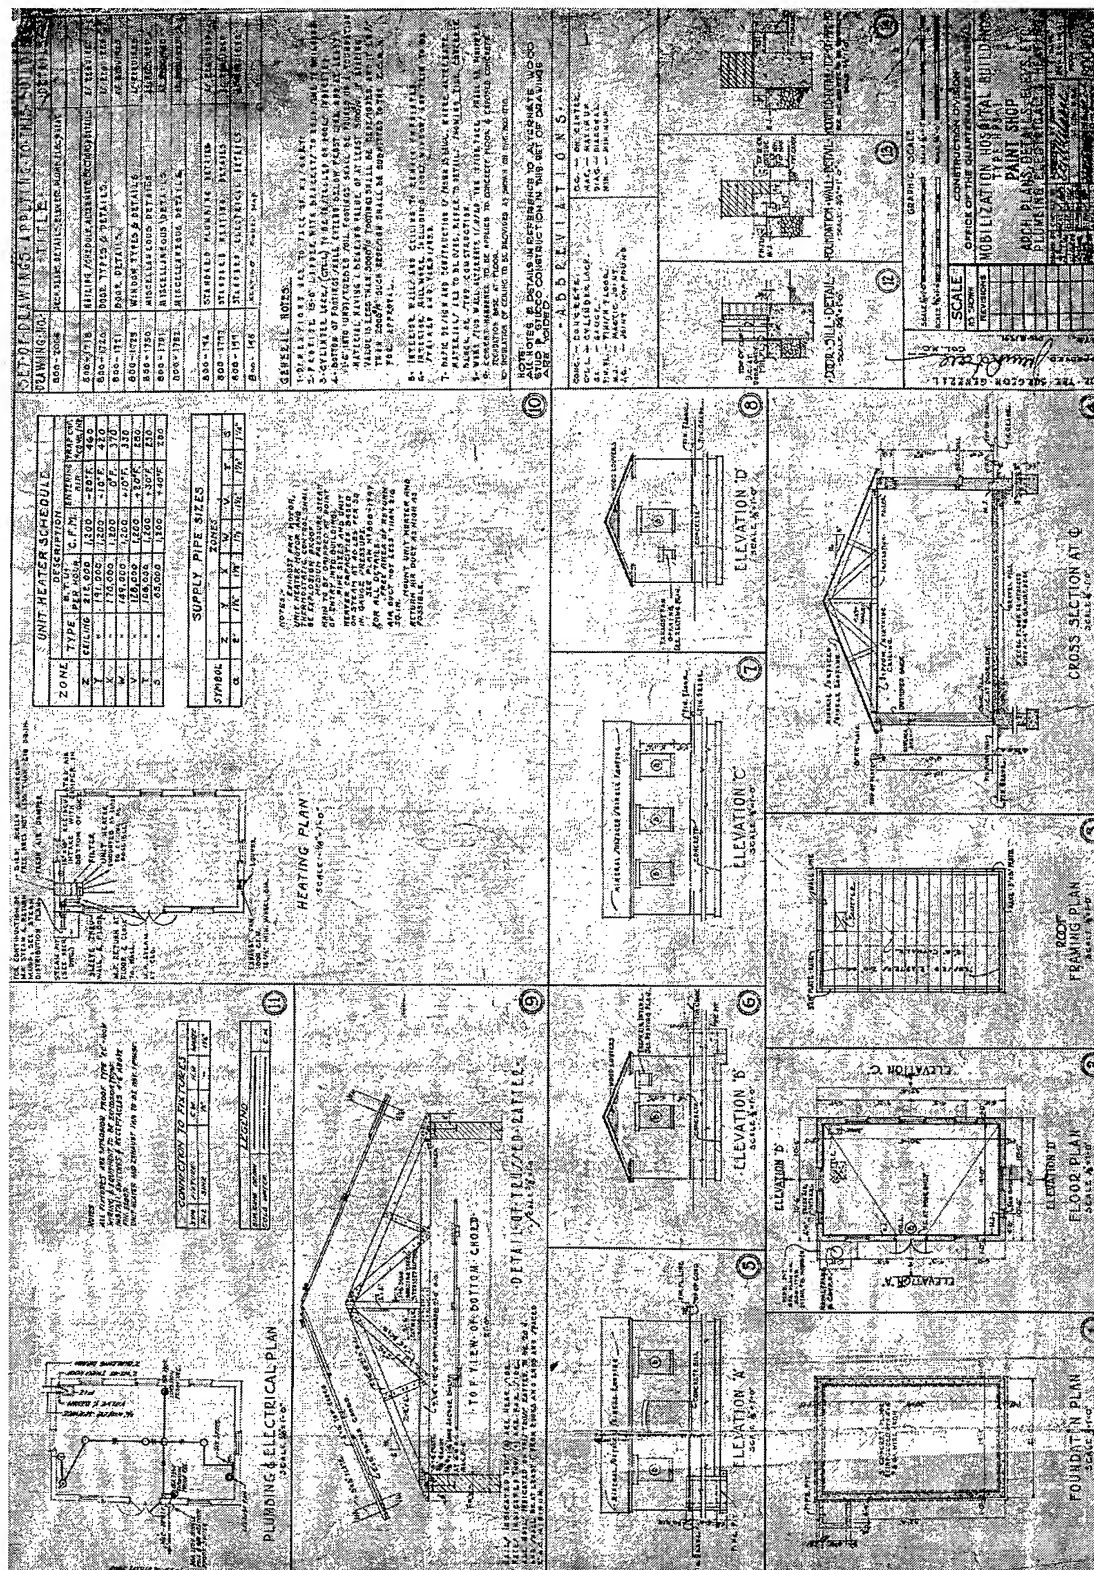
Figure V.235 5EP1778. Architectural plans, details, and elevations for Building S6275, Paint Shop, 800 Series, Type HPS-1, Plan 800-2006.

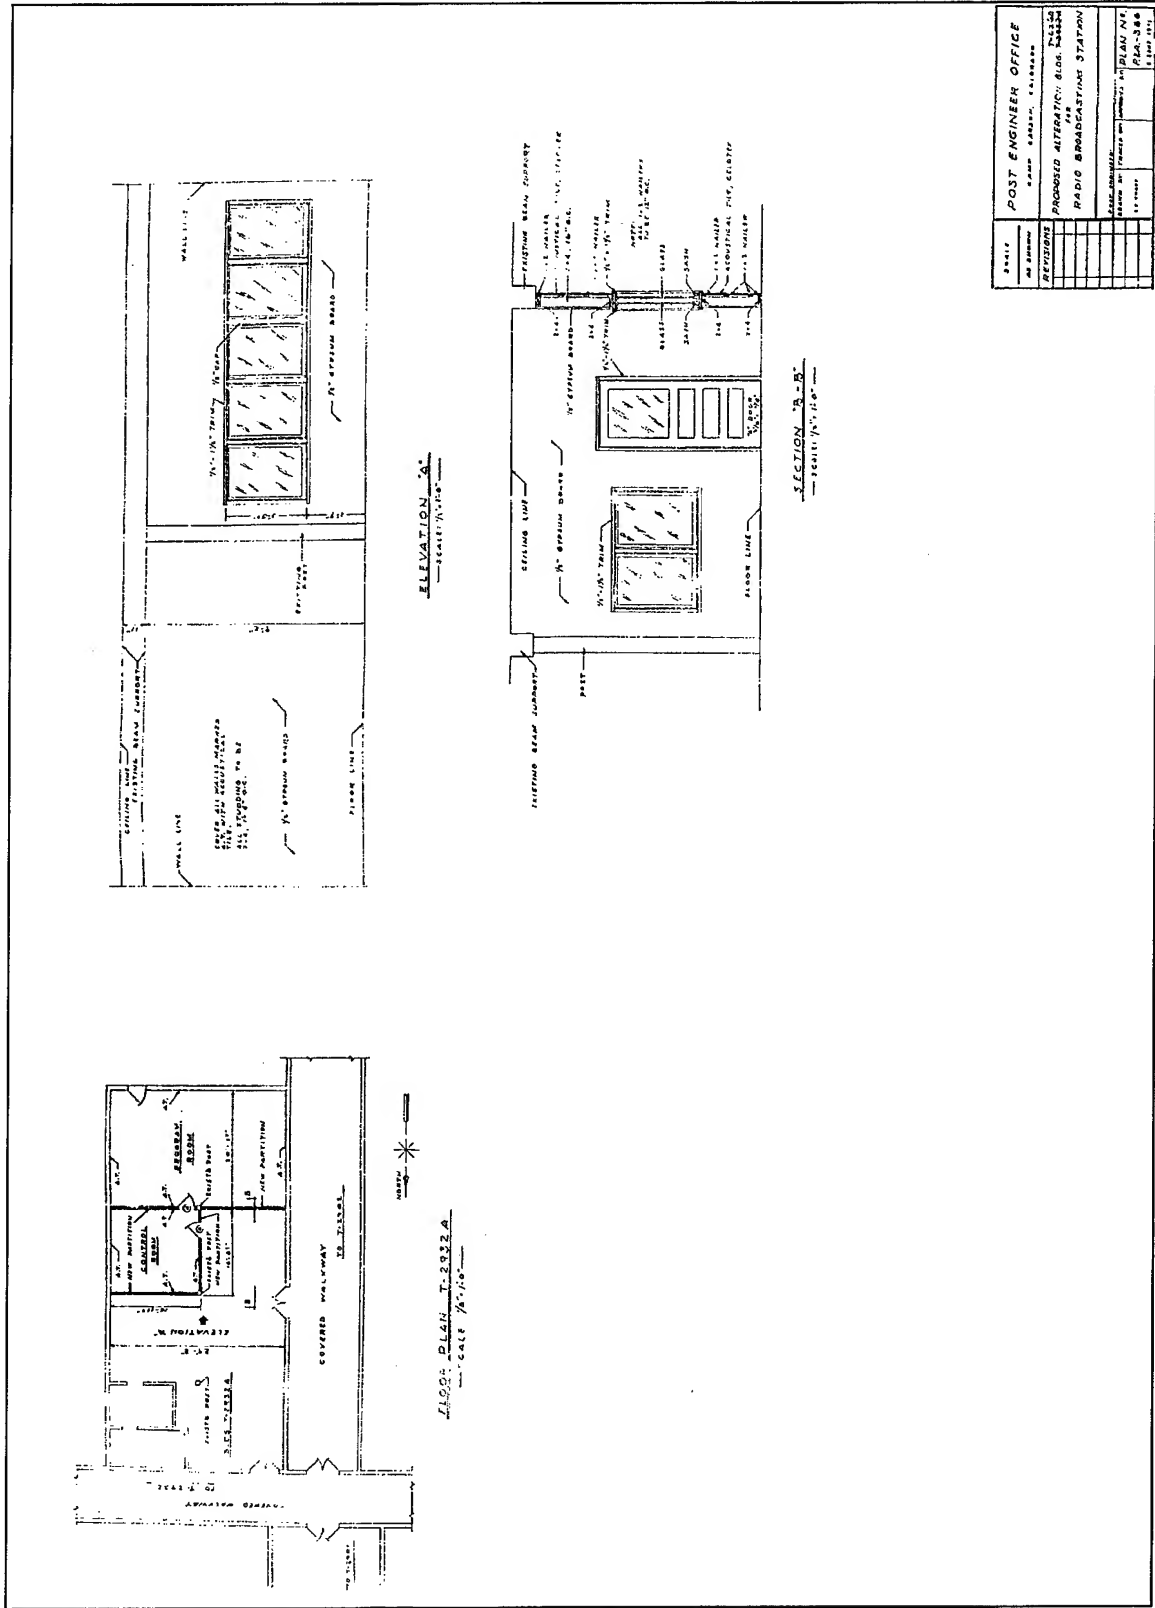
Figure V.238 5EP1778. Proposed alterations for Building S6260, Radio Broadcasting Station, PEA Series, Sheet 386.
